*Test methods for external fire exposure to in accordance
with CEN/TS 1187:2012 (t1) of Mobilane MobiRoof ECO*

Test report

Reportnumber Y 3428-2E-RA-001 d.d. 17 September 2025

Product **Mobilane MobiRoof ECO**

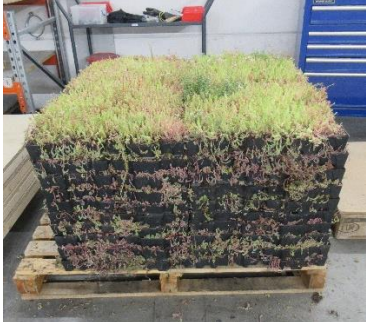
Product		
Date of delivery	28/05/2025	
Commercial name	Mobilane MobiRoof ECO	
Produced by	Name	Mobilane B.V.
	Address	Viola 3 6681 RA BEMMEL The Netherlands
Identification	Batch no	2024July
Sampling	Date	27 May 2025
	Performed by	Mr. D. Lauwerijssen
Photo

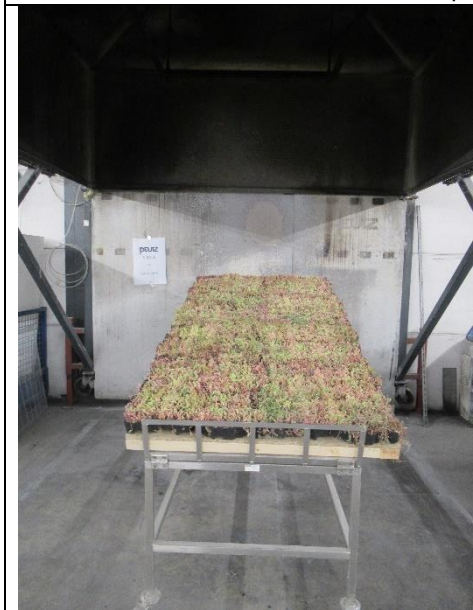
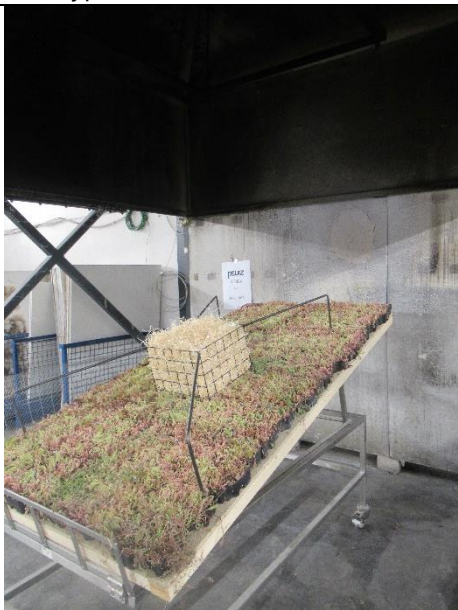
Test specimen 1 – type 1

Test specimen before testing

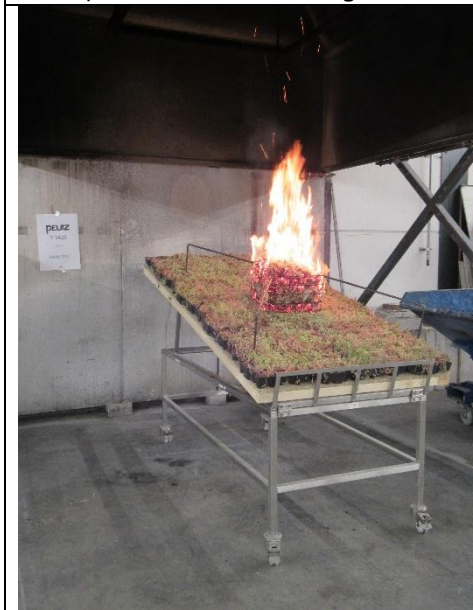
Test specimen during testing

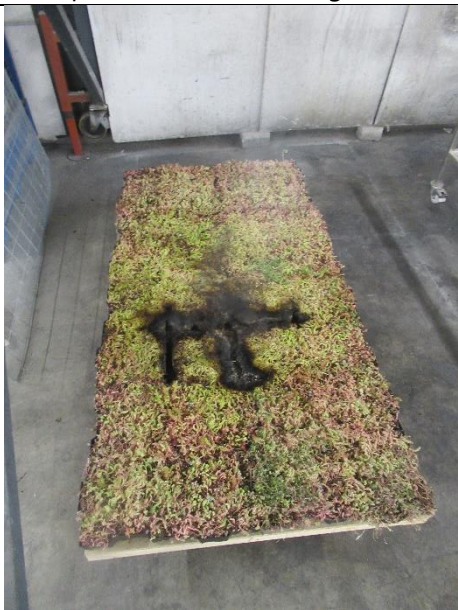
Test specimen after testing

- upwards	0	50	0	40
- downwards	265	20	20	30
- left	195	30	30	20
- right	150	0	10	0

Specimen 1 Type 1	Specimen 2 Type 1	Specimen 3 Type 2	Specimen 4 Type 1
Opening test specimen [hh:mm]	01:01	01:02	01:07	01:03
	layer 1: burnt 125 mm ↑ 265 mm ↓	layer 1: burnt 50 mm ↑ 20 mm ↓	layer 1: burnt 0 mm ↑ 20 mm ↓	layer 1: burnt 40 mm ↑ 30 mm ↓
Burnt length in [mm] and extent internal damage (TS 1187, 4.8.4.1), per layer, from the edge of the brand	Layer 2: burnt 0 mm ↑ 300mm ↓	Layer 2: burnt 0 mm ↑ 0mm ↓	Layer 2: burnt 0 mm ↑ 0mm ↓	Layer 2: burnt 0 mm ↑ 0mm ↓
Max. length burnt material from the edge of the brand (TS 1187, 4.8.4.2), per layer	layer 1: 390 mm	layer 1: 70 mm	layer 1: 20 mm Layer 1: 0.035 m ²	layer 1: 70 mm
Extent of internal damages (TS 1187, 4.8.4.3), per layer, total value	Layer 1: 0.14 m ² Layer 2: 0.19 m ²	Layer 1: 0.04 m ² Layer 2: 0.00 m ²	Layer 2: 0.000 m ²	Layer 1: 0.05 m ² Layer 2: 0.00 m ²

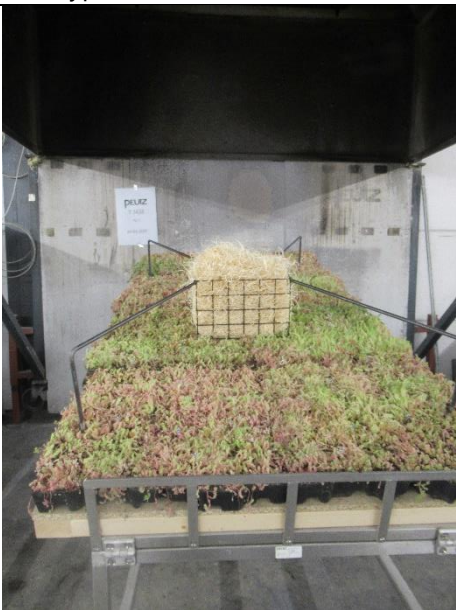
Test specimen 2 – type 3

Test specimen before testing

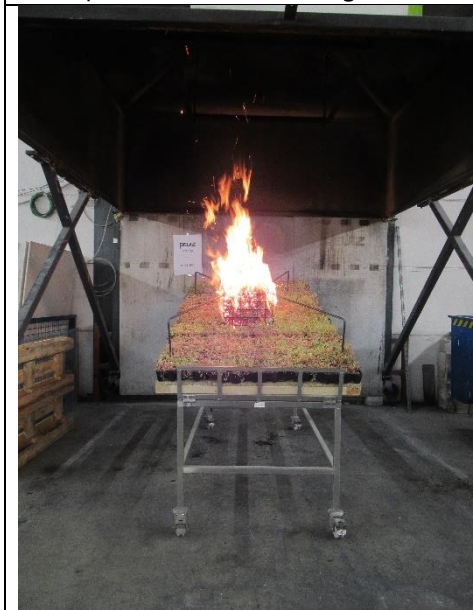
Test specimen during testing

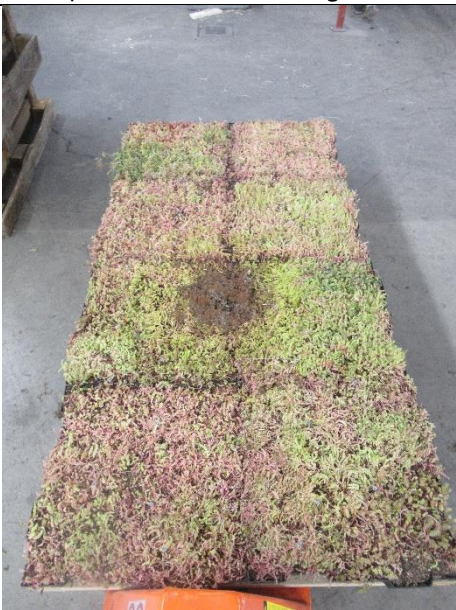
Test specimen after testing

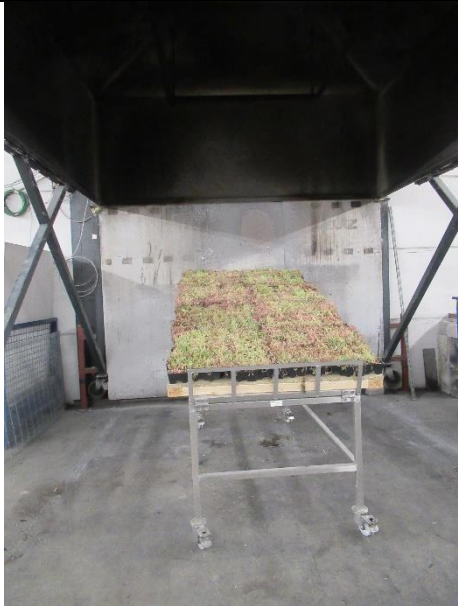
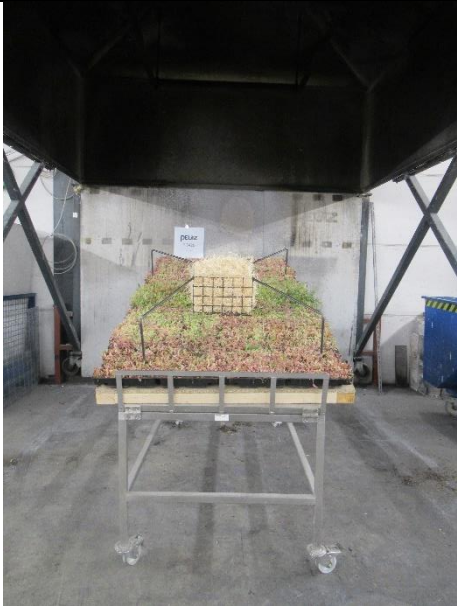
Test specimen 3 – type 2

Test specimen before testing	Test specimen before testing

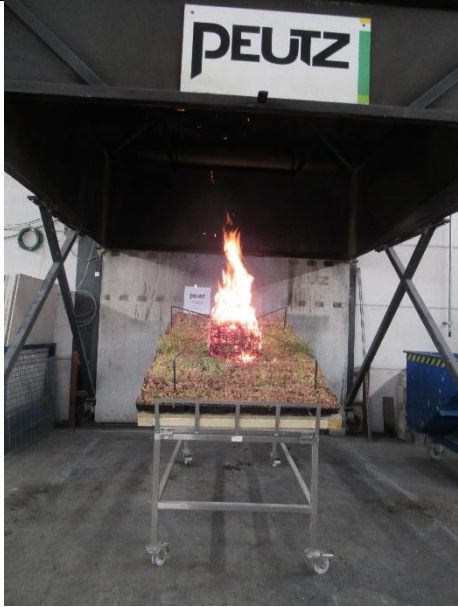
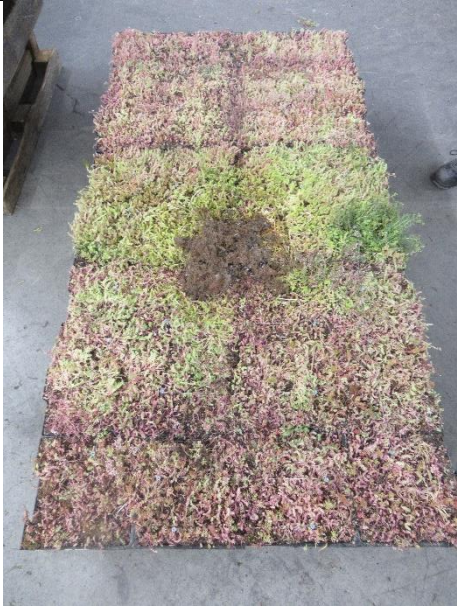
Test specimen during testing	Test specimen after testing

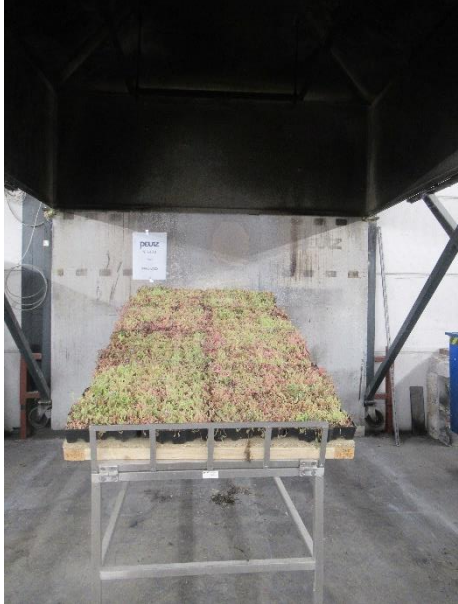
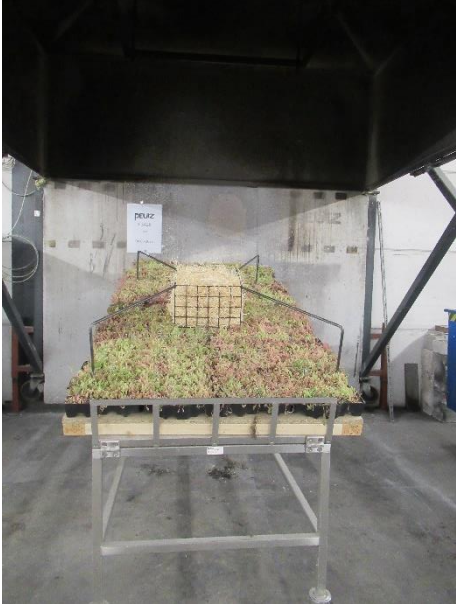
Test specimen 4 – type 3

Test specimen before testing	Test specimen before testing

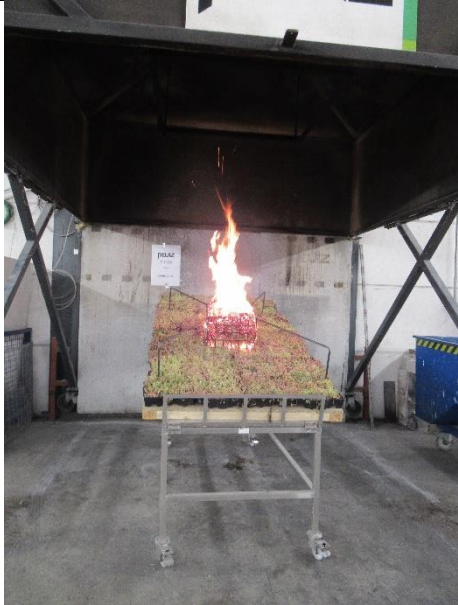
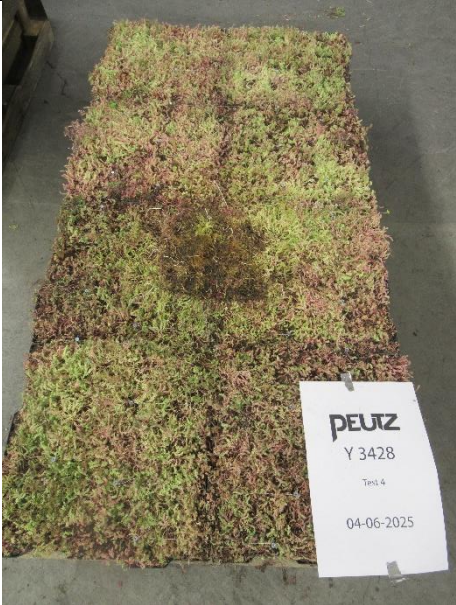
Test specimen during testing	Test specimen after testing
